**SAS Superstructure**

**Daily Diary Report by Bid Item**

Contract No.: 04-0120F4

Diary #: 114 Const Calendar Day: 651 Date: 21-Jun-2011 Tuesday

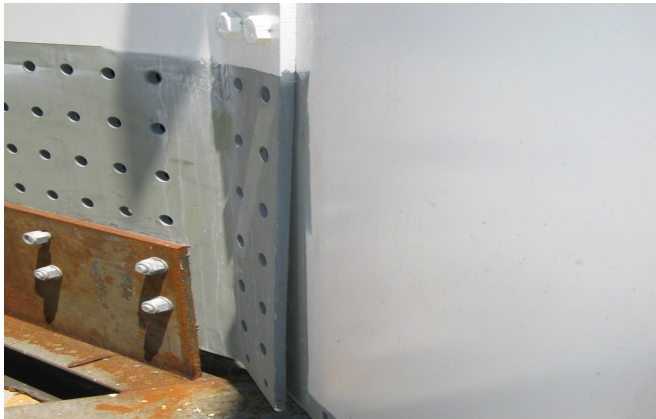
However, there was one area of concern. The bolted connection near the D-F corner of the South shaft is warped, and has a gap of 20mm between the plies of the bolted connection. It does not appear as if it was shipping damage because there are no scrapes or dings to the paint in this area. This will need to be addressed during the erection of the Tower head.

South shaft, D-F corner splice connection

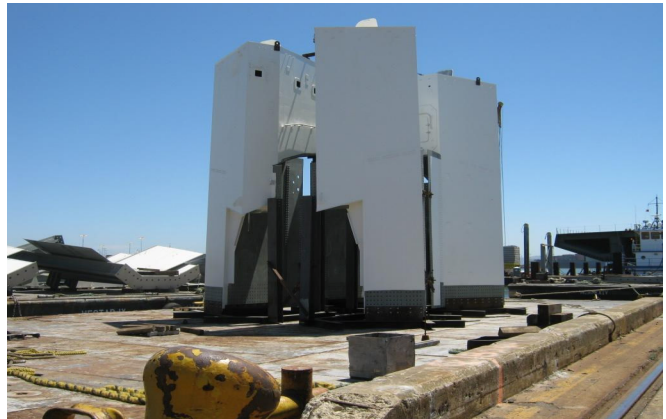
We performed the arrival inspection of the Tower head and skirt to check for any shipping damage. Attending were Chuck Kanapicki and Mike Johnson for ABF, and Sanny Khow, Scott Croff, and myself from Caltrans. There did not appear to be any damage from shipping.

Tower head with Tower skirt in the left background
